**Investigation of Toe Tip Necrosis Syndrome in Feedlot Cattle using
Biomechanical Testing and Imaging**

A Thesis Submitted to the College of
Graduate and Postdoctoral Studies
In Partial Fulfillment of the Requirements
For the Degree of Master of Science
In the Division of Biomedical Engineering
University of Saskatchewan
Saskatoon

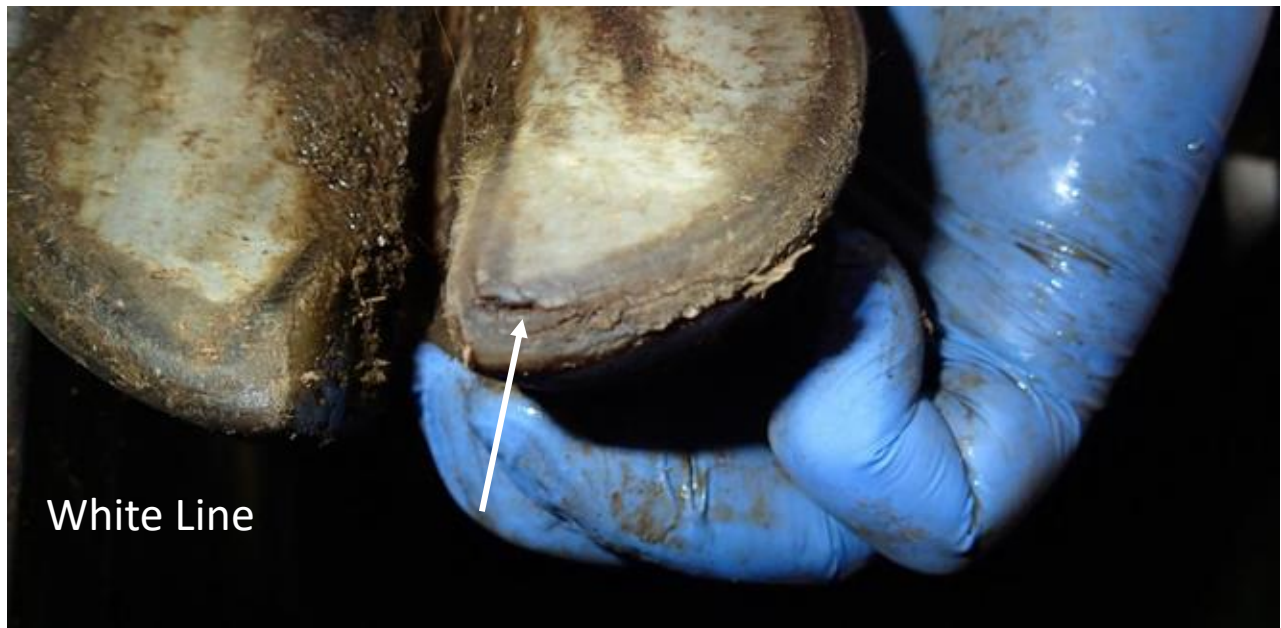
Figure 1-4 Image of the ground surface side of a bovine hind limb. This hoof has early stages of TTNS. The White line is separated; however, it is not clear and could go undiagnosed.

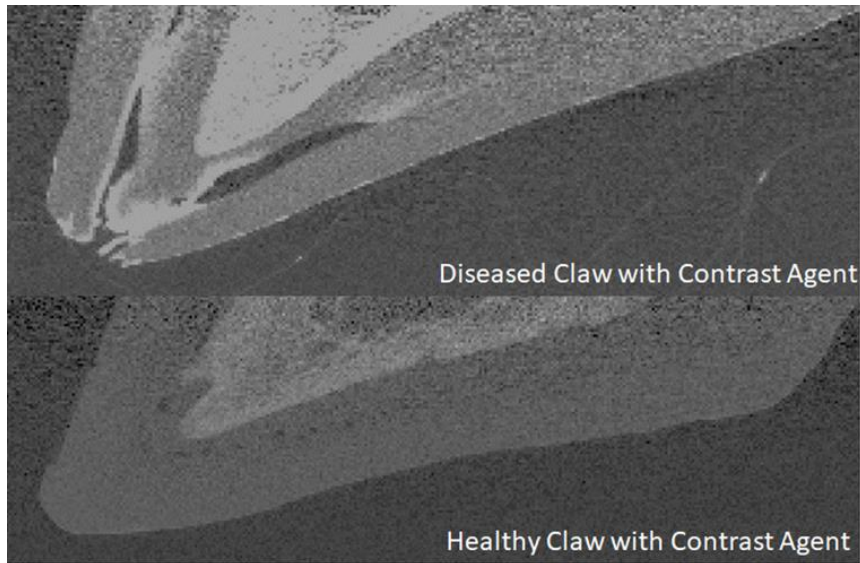
Figure 3-6 Sagittal slice of healthy and diseased bovine hoof. This hoof has had contrast agent pulled up into it via the contrast agent pump. The contrast agent has accessed the hoof and sits in the spacing.

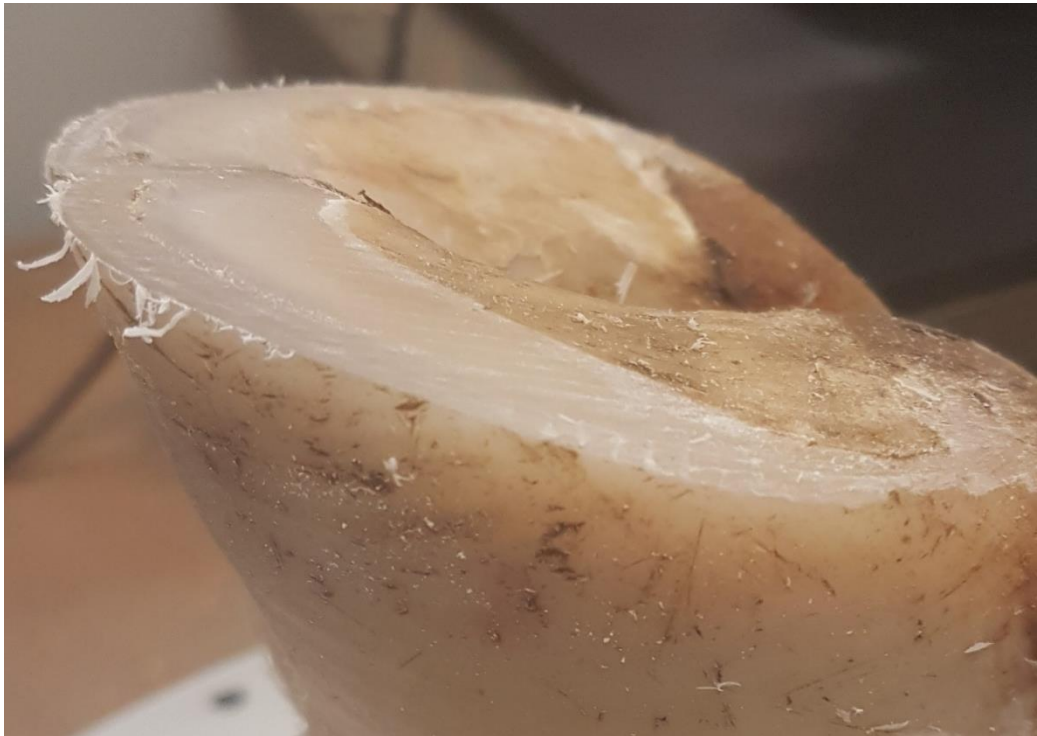
Figure 4-1 Image showing a hoof that has had mechanical damage induced with a veterinary file. The file was used to rasp down hoof material.

feedlot via rasping. Damage was induced via a veterinary hand file by rasping down the hoof based on reported thinning of the sole (5). Hooves were rasped down between 6 – 8 mm. A 3D digitizer was used to identify the surface of the hoof pre- and post- rasping. Surface points were fit to a plane (Matlab), with the difference in plane heights defined the level of rasping. The figure (Fig. 4-1) below shows a hoof that has been rasped. This amount of material was removed near the thickness of the hoof sole, so discretion was used to avoid filing away all of the keratin. Pre- and Post measurements were done with a ruler to help perform a uniform removal of material.

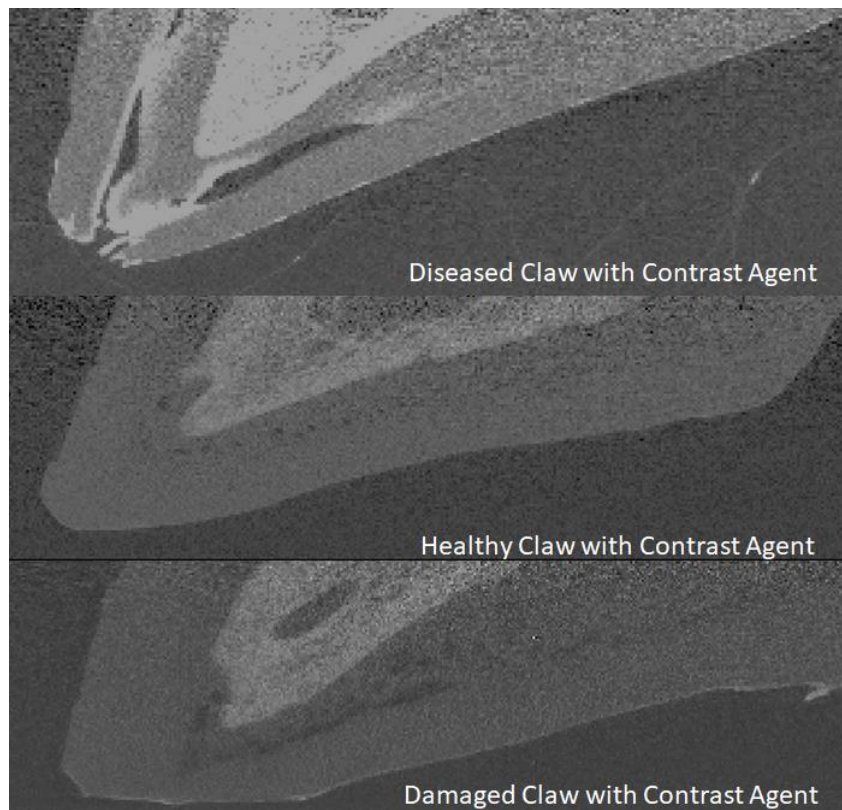
Figure 4-3 Sagittal sections of HR-pQCT scan volumes at the apical toe. Healthy and damaged hooves show no contrast agent penetrating the white line. A diseased hoof is shown for comparison from the previous study.

Paired tests of contrast enhanced HR-pQCT scanned volume indicated no significant differences between the healthy controls and the diseased hooves (Mean ±SD volume: Damaged = $0.12 \pm 0.17 \text{ mm}^3$, Healthy = $0.14 \pm 0.25 \text{ mm}^3$; $p=0.90$). Shown below in Figure 4-3 are sagittal sections from HR-pQCT scans of a healthy and damaged hoof. These show that no contrast agent penetrated the white line. A diseased sagittal section is shown for comparison.

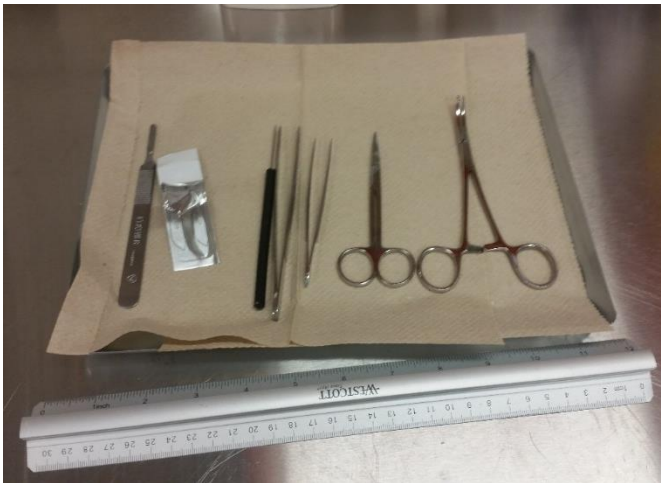
Figure 6-1 Dissection tools
